TEST SUMMARY # 17

STRONGBACK COMPOSITE REPAIR SYSTEM FOR DAMAGED PIPES

CLIENT: BOTAS PETROLEUM PIPELINE CORPORATION

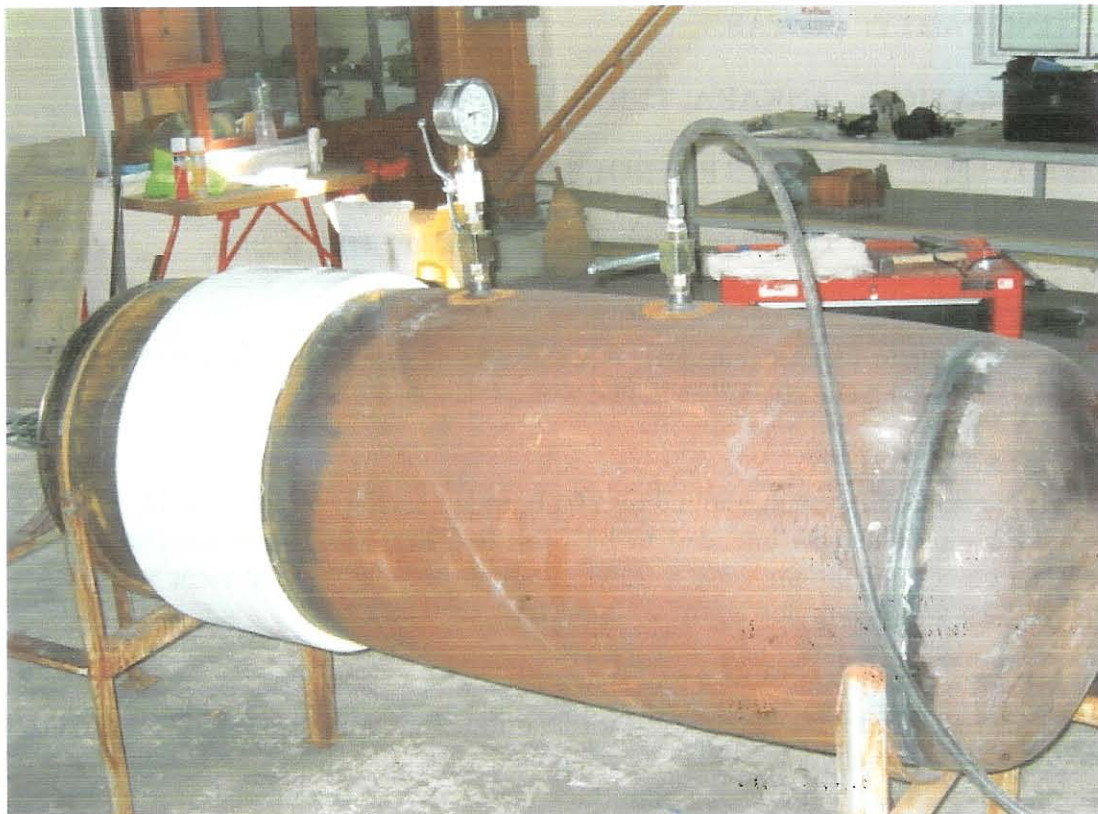
Pipe pressured to the regular pipe test level of 102.5 barg and easily held for 15 minutes. The pressure was gradually increased to 137.5 barg, the limit of the pump. At this pressure deformation of the virgin pipe was clearly visible but the StrongBack reinforced section showed no deformation.

**AT PUMP LIMIT, PRESSURE OF 137.5 BARG REACHED.
STRONGBACK REPAIR SEEN CONTAINING EXPANSION AS UNWRAPPED
PORTION OF PIPE SHOWN BALLOONING.**

The defect was filled with the StrongBack load transfer epoxy # GS-154 followed by the epoxy # GS-561 undercoat which was applied over the defect and around the pipe circumference. Five (5) rolls of StrongBack tape # SB-1290 wrapped over the epoxy, to provide approx. 30 layers.
